IMPORTANT SERVICE ALERT 16-TSB19 MD68/MD75 MOLDBOARD WELDING

MD75 Moldboard 16020420 MD68 Moldboard 16020410

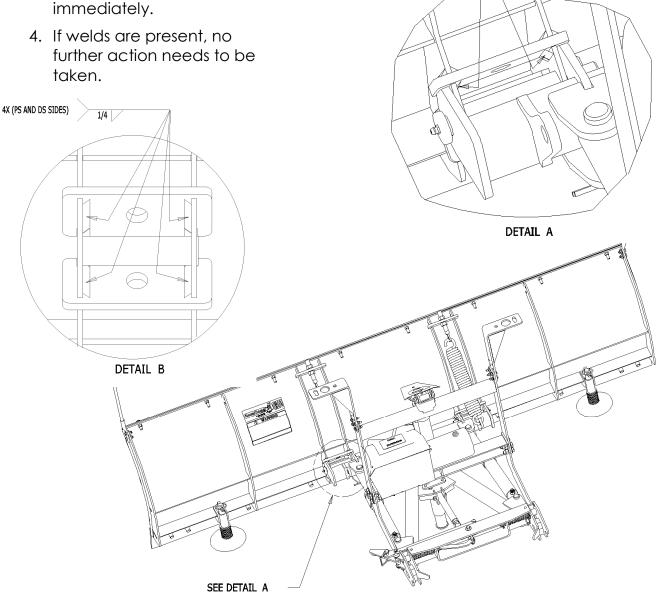
It has been determined that a small number of MD moldboards were shipped with missing welds due to a programming error.

- Stand behind the moldboard on the Drivers Side please note that drivers side trip spring is not shown for clarity. It does NOT need to be removed for inspection.
- 2. The welds in question are on the inside corners of the trip ribs and trip plates as shown below. It is only necessary to inspect the upper corners. There SHOULD NOT be welds where the sector trip stop plate hits the moldboard trip stop plate. The welds in question are BETWEEN the trip ribs on the moldboard as shown below.
 CONFIRM WELD IN THESE LOCATIONS
