# SnowDogg

## SERVICE ALERT

16-TSB14

### MD A-FRAME/SECTOR KING BOLT

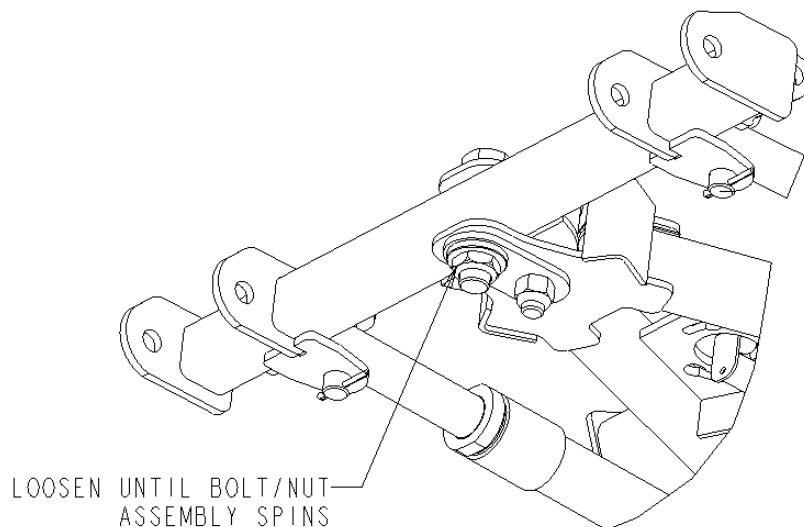
On certain MD Lift Frame's, the king bolt securing the sector to the a-frame was **over-tightened**. While the plow will function normally, this will result in decreased speed and increased wear on the painted surfaces of the sector and a-frame.

This can be rectified by loosening the nylock nut on the underside of the a-frame that secures the king bolt.

Loosen the nut until the nut/bolt assembly begins to spin freely. This will increase the angling speed of the plow and reduce power drain on the vehicle.
