**TECHNICAL
SERVICE BULLETIN**

| NUMBER | 16TSB-91 | | | TYPE | APPLICATION ALERT | | | |
| TITLE | 16071300 HEADLIGHT ADAPTER 2020+ FORD SUPERDUTY LED HEADLIGHTS (PLATINUM) | | | | | | | |

16TSB-91 ADDENDUM

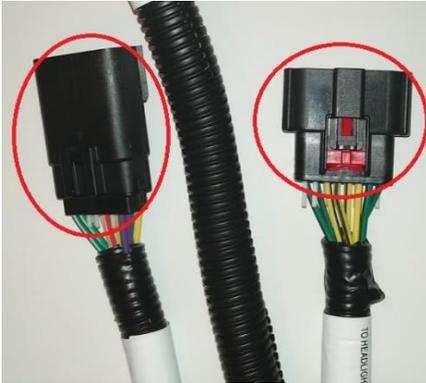
1. Locate the connectors shown on 16071200 – these are what you will be modifying. On both, you will be swapping pins 7+8, and pins 9+10.
