TECHNICAL SERVICE BULLETIN

by Buyers mm								
NUMBER	16TSB-103			TYPE	SERVICE ALERT			
ROUTING	INSTALL	Х	SERVICE	Х	SALES	PURCH		
TITLE	GMC/CHEVY TRUCK INSTRUMENT CLUSTER/RADIO BEHAVIOR							
REV		-		ISSUED	11	/21/2022	REVISED	
AFFECTS	2014+ GMC/Chevy Pickup Trucks							
INFORMATION	GM has released several bulletins about erratic truck instrument panel behavior when used with a snowplow These may be found at gmupfitter.com under 161B and 124K and are attached for your convenience.							
	https://www.gmupfitter.com/wp-content/uploads/2021/08/UI-Bulletin-161b.pdf https://www.gmupfitter.com/wp-content/uploads/2021/05/UI-Bulletin-124k.pdf							
INSTRUCTIONS	If a truck exhibappropriate ha		e symptom:	s, contact	your GMC/	Chevrolet deale	to have yo	ur truck updated with the

UI Bulletin #161b

Subject: Resets on Snow Plow Trucks

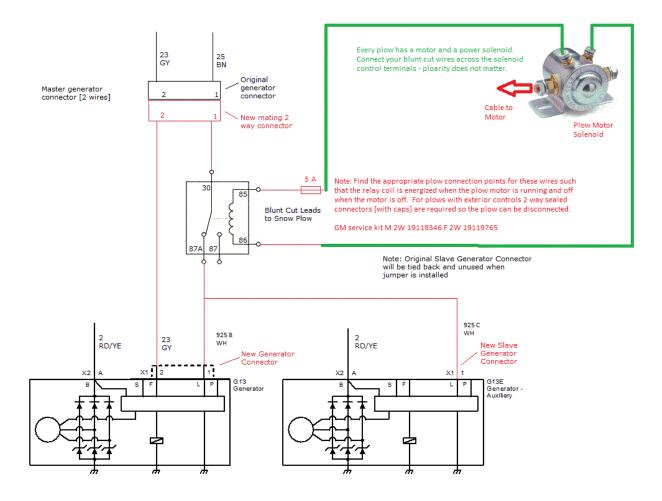
Fig 1: Jumper harness wiring schematic

VYU Service Harness for both single and dual generator trucks

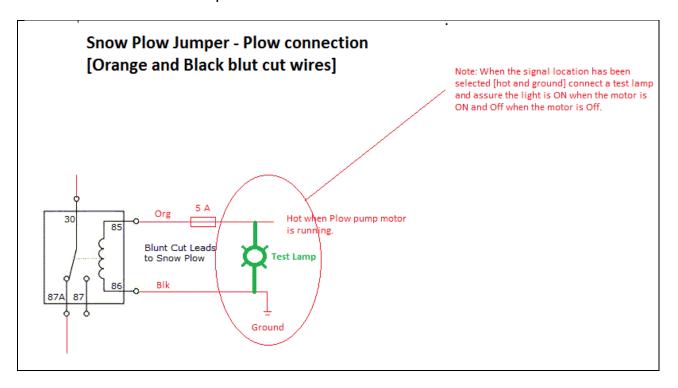
Note: To identify the signal needed by the jumper harness perform the following test. Any connection point that passes this test can be used. The best case is a signal from the wiring that remains with the truck but if that is not found then the signal must be found out on the plow itself.

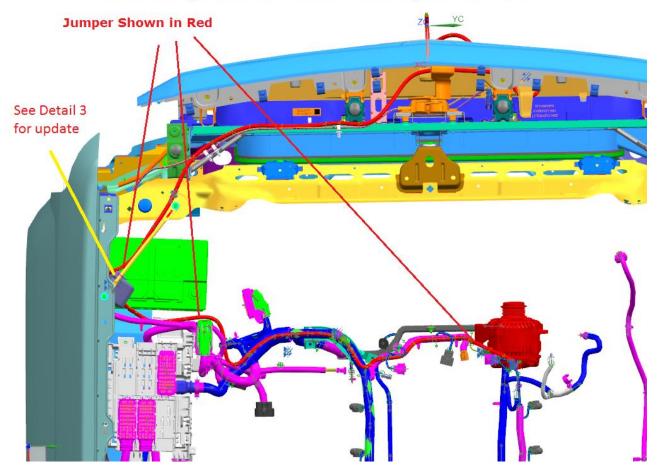
Fig: 3a Jumper Harness Layout – single alternator [see detail 3 for updated relay mounting]

VYU Single Alternator - Jumper Harness

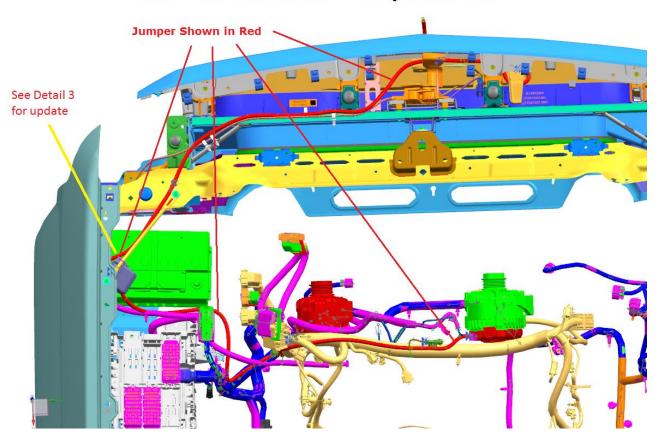
Fig: 3b Jumper Harness Layout – dual alternator [see detail 3 for updated relay mounting]

VYU Dual Alternator - Jumper Harness

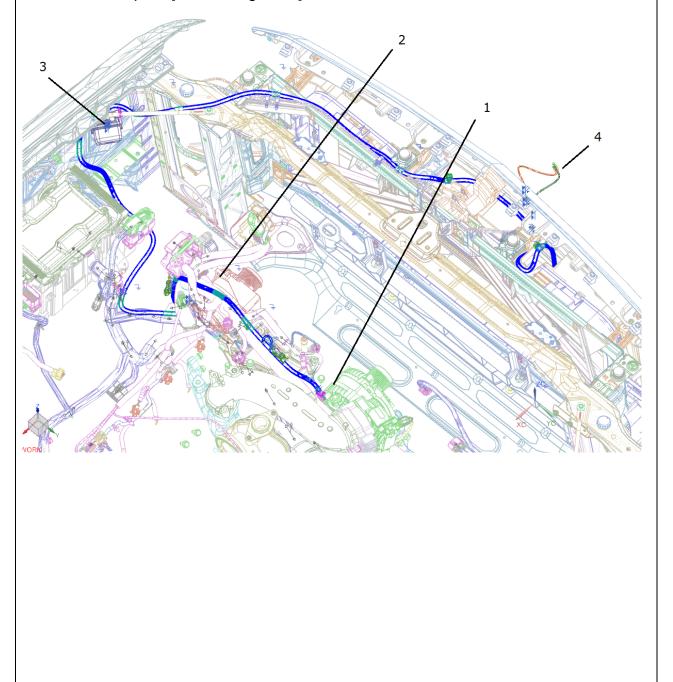
Layout Details

- 1. Primary Alternator
- 2. Slave Alternator
- 3. Relay Center and [new] corner brace
- 4. Wires to plow [fused + & ground]

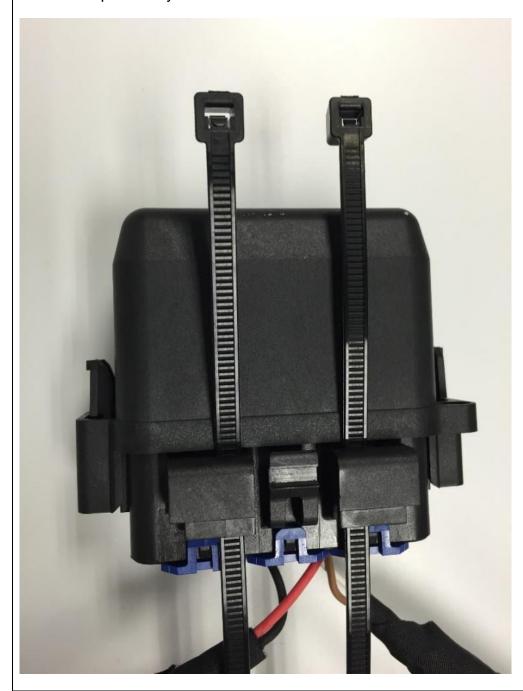
Detail 3.1.1

Details 3.1.1-3 apply to service part and not the factory included [loose shipped] part.

Add tie straps to relay

i) Route the snow plow jumper harness along the existing harness routing where possible and secure the relay center with tie straps as shown in Details 3.1.1-3. Allow slack for engine roll and upright orientation of the relay center to prevent water intrusion/collection.

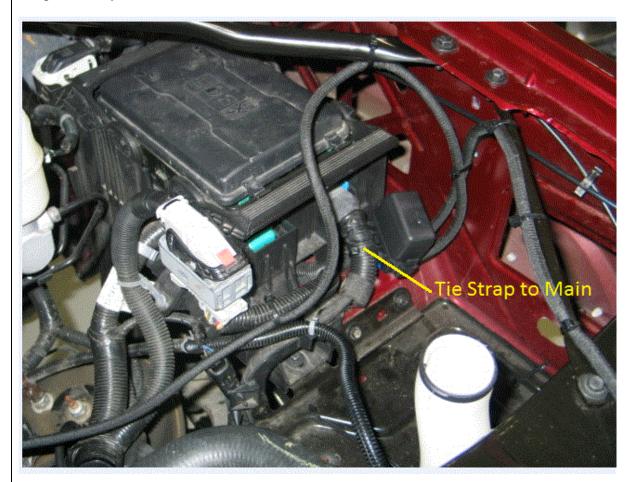
Detail 3.1.2

Single Battery Trucks

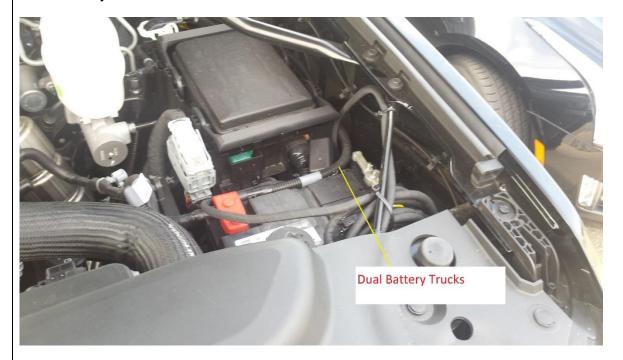
Detail 3.1.3

Dual Battery Trucks

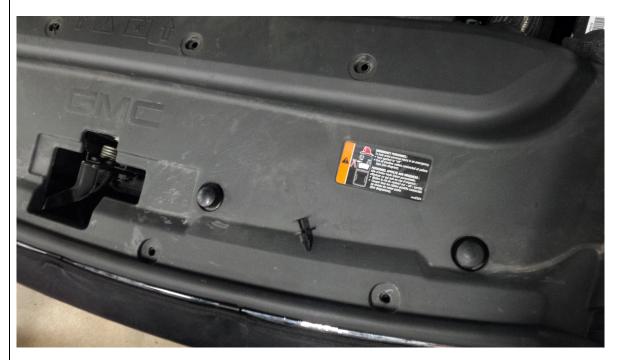
Detail 3.2.1

The following details 3.2.1 – 7 apply only to trucks that came with harness components [loose shipped] from the assembly plant.

Remove the Radiator Air Upper Baffle and Deflector.

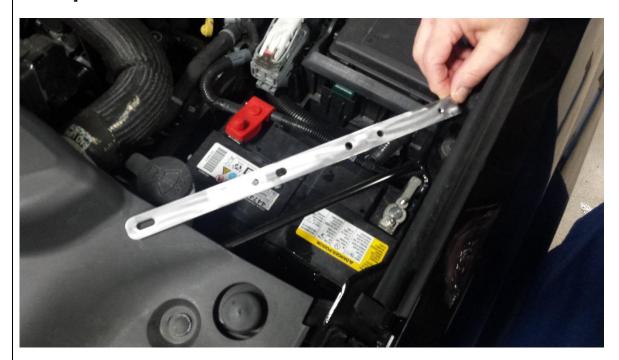
Detail 3.2.2

Identify the new flat painted corner brace pn 84234282. [unpainted version shown]
