TECHNICAL SERVICE BULLETIN

NUMBER	16TSB-81			TYPE	SERVICE ALERT			
ROUTING	INSTALL	X	SERVICE	X	SALES		PURCH	
TITLE	SWITCHED GROUND INSTALLATION - G2 HARNESS							
REV	A			ISSUED	10/31/2018	REVISED	-	
AFFECTS	16011002/16012002/16013002 G2 LIFT FRAMES

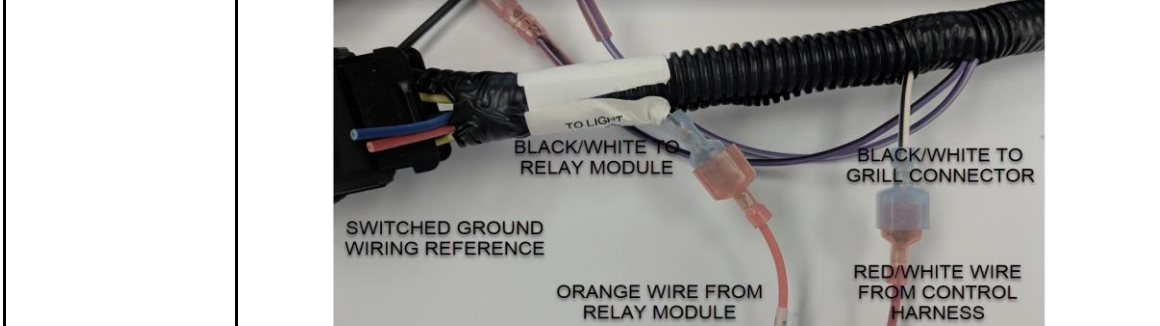
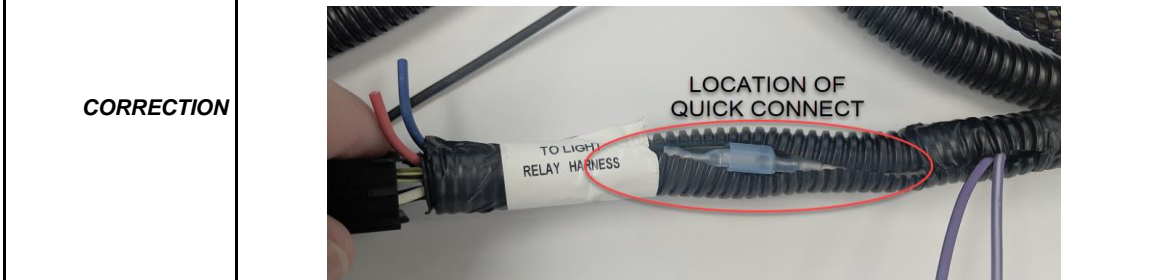
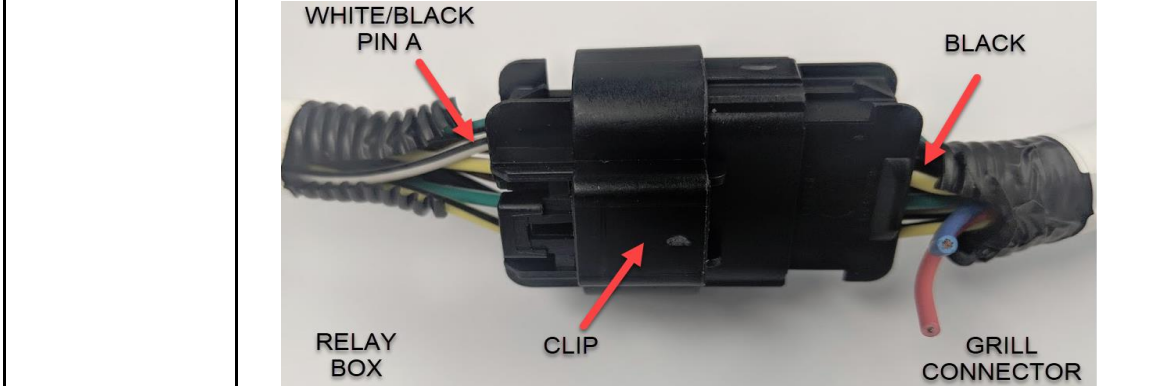
INFORMATION
 There have been reports of miswired relay harnesses in the field. This does not affect normal installations - **but does affect switched ground installations**. The below instructions should clarify any steps that need to be taken. Verify your harnesses against the figures below, and if necessary correct the wiring.

Current production harnesses should have the BLACK wire paired with the BLACK/WHITE wire as shown in the pictures. If you have BLACK paired to BLACK - the controller fuse (or the fuse will tapped into) will blow. Swap the BLACK and WHITE/BLACK wires on the RELAY BOX HARNESS. *While you CAN swap the wires on either connector, the relay box harness is easier.*
