SnowDogg

SERVICE ALERT

16-TSB15

GM 2007+ TOYOTA TUNDRA 2007+ LIGHT ADAPTER 16071160

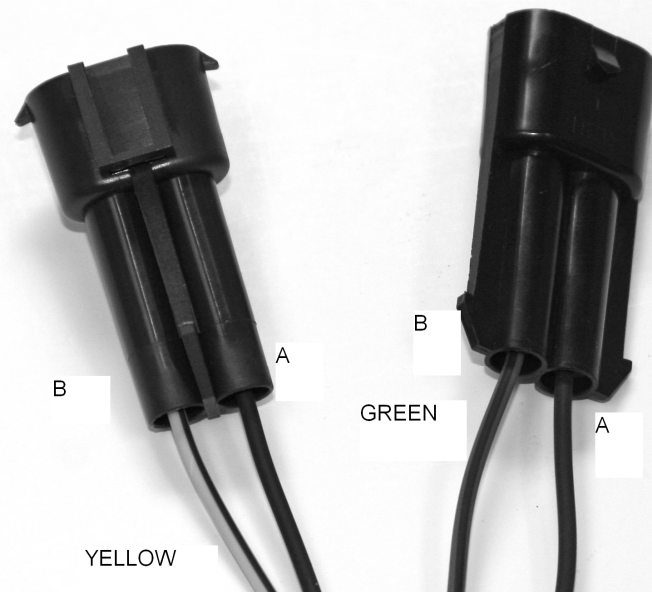
CORRECT WIRE CONFIGURATION

IT has been determined that most 16071160 light adapters shipped prior to 09/12/08 have a wiring error that will result in malfunctioning plow lights.

This will not damage the truck or plow lighting circuit.

Customer may contact BPC for replacement adapters, or the problem may be corrected by the installer by swapping the wires at the LONG connectors on the 16071160 harness. This will MATCH THE TRUCK LIGHT HARNESS color scheme.

Reinsert the terminals as shown on the first page. The wire colors should now match the truck lighting harness (GM). If they do not, recheck the adapter.

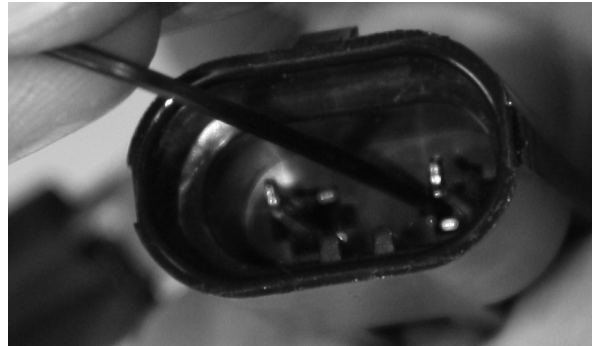
On the connector with the green wire, the pick should be inserted on the inside face of the terminal. You are pushing back a small metal retaining piece, which will allow the terminal to be removed.

Removing the terminals for both long connectors can be done easily with a stiff pick or pin. In the pictures below a small hex key was used. Paper clips are too flexible.

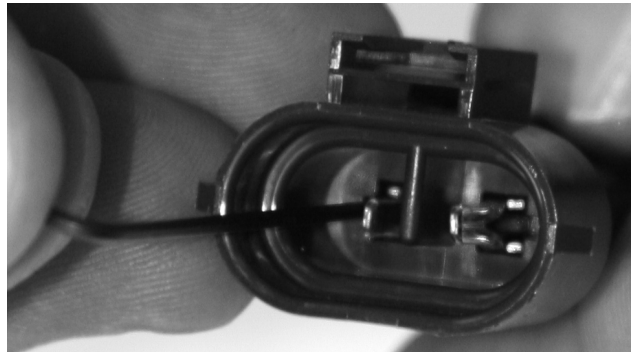
On the connector with the yellow wire, the pick should be inserted on the outside face of the terminal.
