NUMBER	16TSB-85			TYPE	SERVICE ALERT		
ROUTING	INSTALL	X	SERVICE	X	SALES	PURCH	
TITLE	G2 HPU MOTOR DRAINAGE - DRAIN PLUG ORIENTATION						
REV	A			ISSUED	12/7/2018	REVISED	-
AFFECTS	ALL SNOWDOGG G2 PLOWS - HD2/EX2/VXF2/TE2						
INFORMATION	<p>The motor used on the SnowDogg HPU's has small plastic drain plugs that should be removed to allow drainage of any condensation or water that has entered from normal use. These drain plugs were oriented incorrectly at assembly. This can be corrected by removing the motor cap, removing the plug, and reinstalling the cap at 180 degree rotation from it's original location OR by adding a drain hole (if easier).</p> <p>If a plow is exhibiting "weak" behavior - it's possible that moisture is trapped in the housing causing corrosion/friction. Please correct the drain plug as shown below on any plows brought in for service. The motor service P/N is 16151200</p> <p>This should be also be checked on ALL NEW G2 SnowDogg plows at time of installation to prevent future service issues.</p>

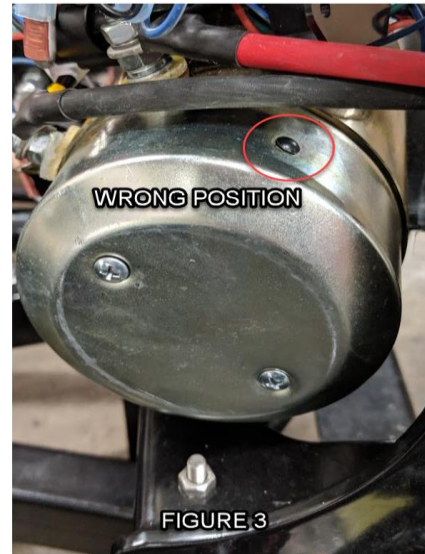
2. Remove the FRONT 3/8-16 screw securing the HPU to the frame (FIGURE 2) and loosen the REAR screw.
3. For XP and VXF - remove the screw through the back of the lift frame to the HPU (FIGURE 2A).
4. The HPU will be able to slide forward and rotate for access to the motor cap screws.
