TECHNICAL SERVICE BULLETIN

NUMBER	16TSB-86			TYPE	SERVICE ALERT					
ROUTING	INSTALL	X	SERVICE	X	SALES	PURCH				
TITLE	G2 CHAINLIFT CYLINDER PIN DAMAGE - DISTRIBUTE IMMEDIATELY TO ALL INSTALLERS AND AFFECTED PLOW OWNERS									
REV	A			ISSUED	12/7/2018		REVISED	-		
AFFECTS	ALL SNOWDOGG G2 PLOWS - HD2/EX2/VXF2/TE2 - PRIMARILY VXF2

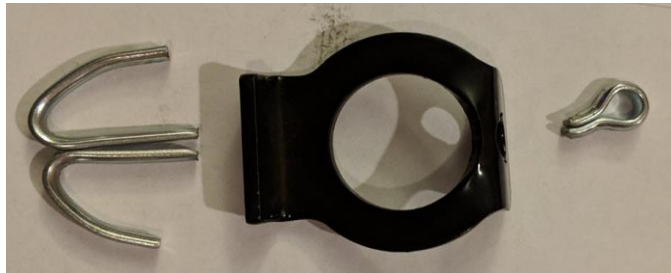
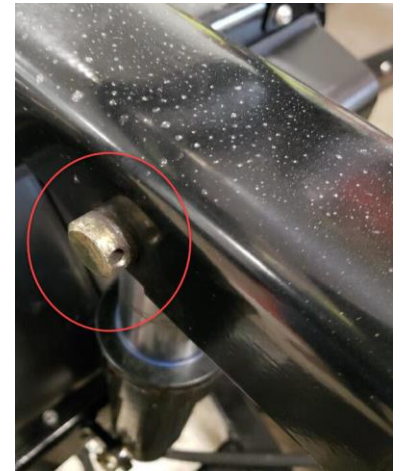
We've received reports of the cotter pin on the chainlift/cylinder clevis pin failing. If not detected, this can cause the clevis pin to come loose and the cylinder to **cause further damage to the plow/lift frame.**
