**TECHNICAL
SERVICE BULLETIN**

| NUMBER | 16TSB-91 | | | TYPE | APPLICATION ALERT | | | |
| TITLE | 16071300 HEADLIGHT ADAPTER 2020+ FORD SUPERDUTY LED HEADLIGHTS (PLATINUM) | | | | | | | |

16TSB-91 ADDENDUM

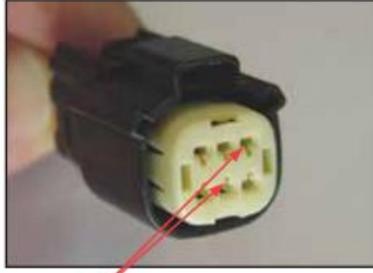
Service Ports

■ Using the 1.50mm (.059") service tool #63813-1500, insert the tip into the terminal service hole adjacent to the terminal to be serviced. Push straight down gently and apply pressure to release-locking finger. This motion will release the locking finger, "picking" is not required. Cavity plugs are removed in the same manner

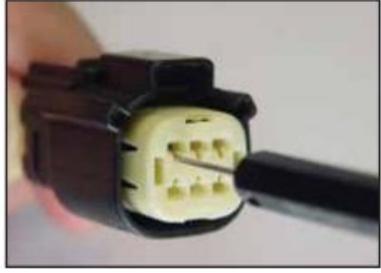
Service Tool must be 90° to the connector face

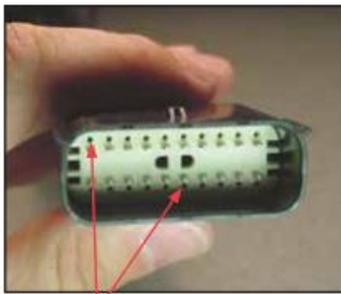
Service Ports

■ Once the Lock finger is disengaged, gently pull on the wire to release the terminal. If the terminal resists, the service tool may not be fully engaged. Push the service tool straight into the service opening to ensure that it has fully disengaged the locking finger

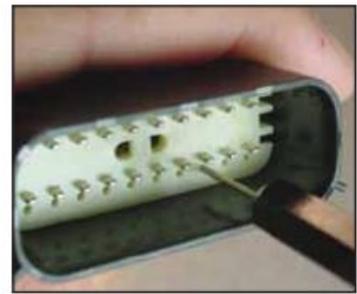
Service Tool must be 90° to the connector face
